Catching up with runaway hot plates[☆]

In recent years, there have been numerous reports of “runaway hot plates”. This is to say, hot plates that heat uncontrollably regardless of the temperature setting or whether the controls are in the off position. Some of these events have resulted in injuries to laboratory personnel and damage to research facilities. Investigations into the cause of several of these events have determined that failure of a non-mechanical switch, a “triac”, in the hot plate can result in the circuit failing open, causing uncontrolled heating. The number of events in recent years has led to greater awareness of the issue; however, in spite of this, devices utilizing this technology continue to be sold and used in research laboratories without additional controls to ensure their safety.

**By Joseph M. Pickel,
Mark Mathews,
Kimberly Brown**

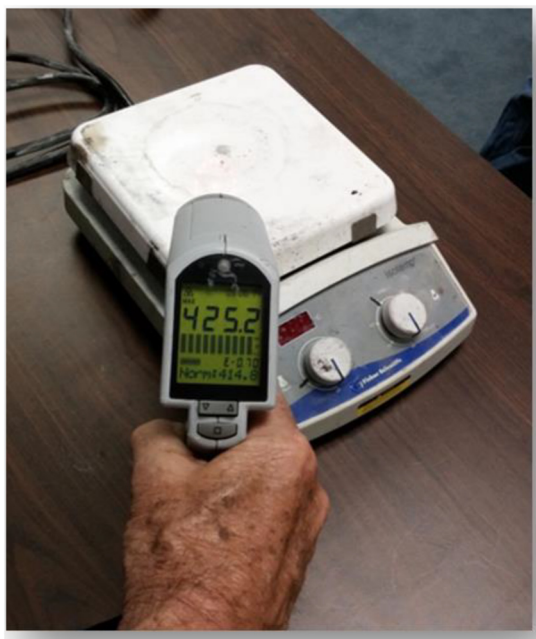
Figure 1. Infrared thermometer indicating elevated temperature on surface of hot plate while heating controls are in “OFF” position.

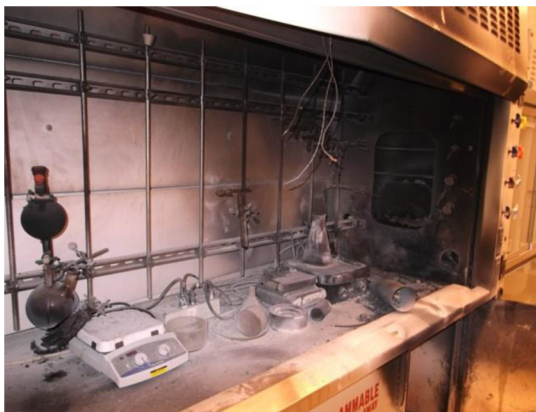
On April 2nd, 2014 a BLEVE (Boiling Liquid Expanding Vapor Event) and fire destroyed a laboratory chemical hood and caused significant damage to a laboratory at Oak Ridge National Laboratory in Tennessee. Portions of the combination sash were jettisoned across the room, damaging a

flammable materials storage cabinet, and the heat of the fire burned a hole into the epoxy surface of the hood. The lab was unattended at the time of the event, and the hood was empty except for a combination hot plate and stirrer (aka stirring hotplate) and a closed 250 mL flask containing hexane. A vacuum pump below the hood was plugged in but turned off as was the heating controller on the hot plate (the stirring controller was in the “On” position). Although initial theories regarding the cause of the fire focused on the vacuum pump, it was later confirmed through forensic analysis that the hot plate had spontaneously and uncontrollably begun heating. An investigation into the reason and mechanism for this phenomenon is noted below.

Figure 2. Damage to hood following BLEVE event.

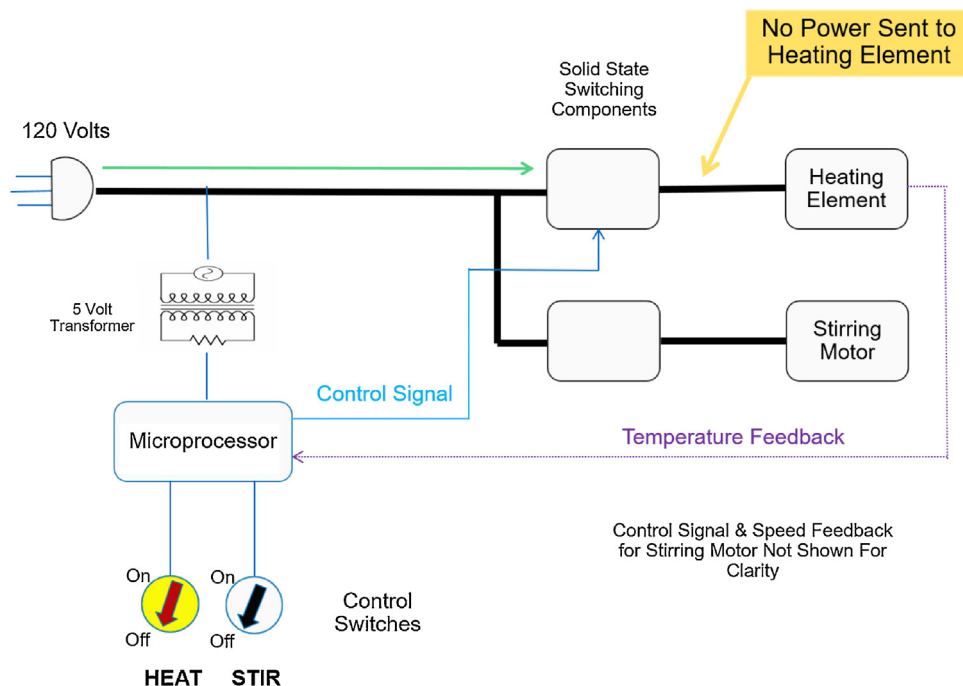
At the start of normal operations, the hot plate is plugged into a receptacle, but the heat control switch is turned off. The microprocessor does not turn on the solid state switching component, and, therefore, no power reaches the hot plate heating element (Figure 3).

Figure 3. Electrical schematic for hot plate plugged in during normal operations.

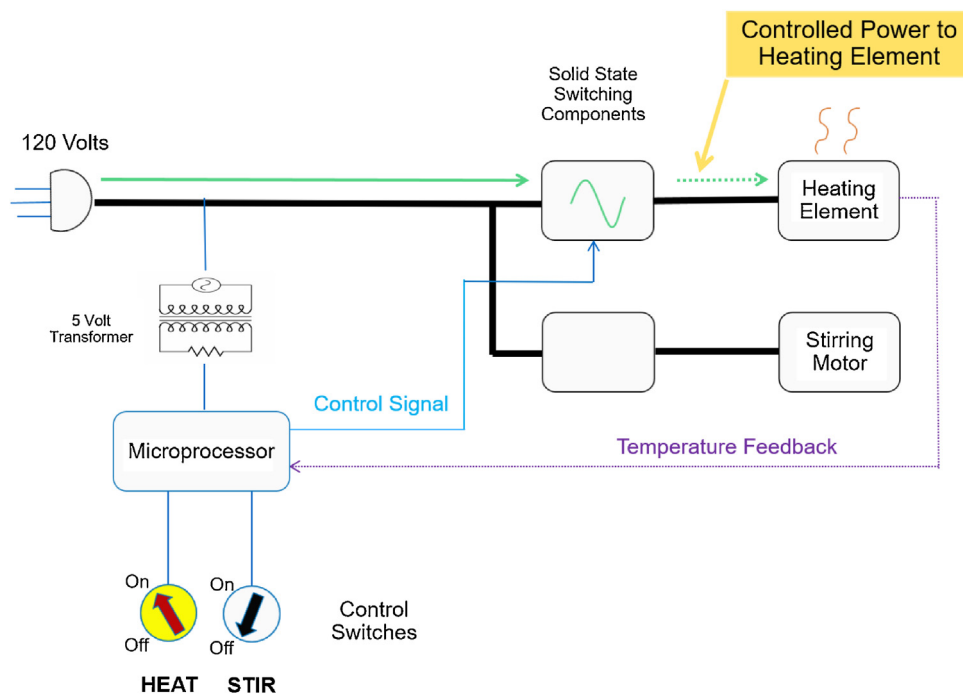
The heat control switch has been turned on. It provides an input to the microprocessor, which in turn sends a control signal to the switching component. The switching component controls the 120-V power to the heating element according to the microprocessor's signal (Figure 4). The temperature feedback loop helps the microprocessor keep the heating element at the desired temperature.

Figure 4. Electrical schematic for hot plate plugged in with power on during normal operations.

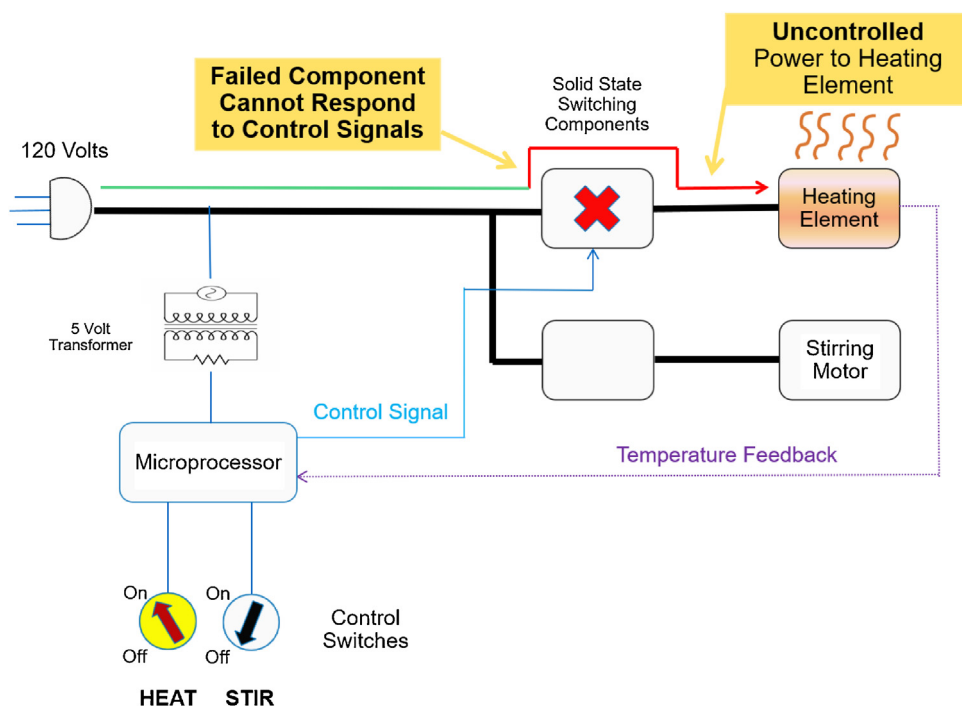
Unfortunately, a well-known failure mode of the switching component typically used in hot plates is that it fails closed (i.e., as a short circuit). A switching component in this condition will allow current to flow directly to the heating element, no longer responding to the microprocessor's control signal. As a result, the hot plate will heat to its maximum temperature. The temperature feedback loop is of no

help in controlling the hot plate temperature. This hot plate has run away (Figure 5).

Figure 5. Electrical schematic for hot plate showing effect (uncontrolled heating) of failed solid state switching component.

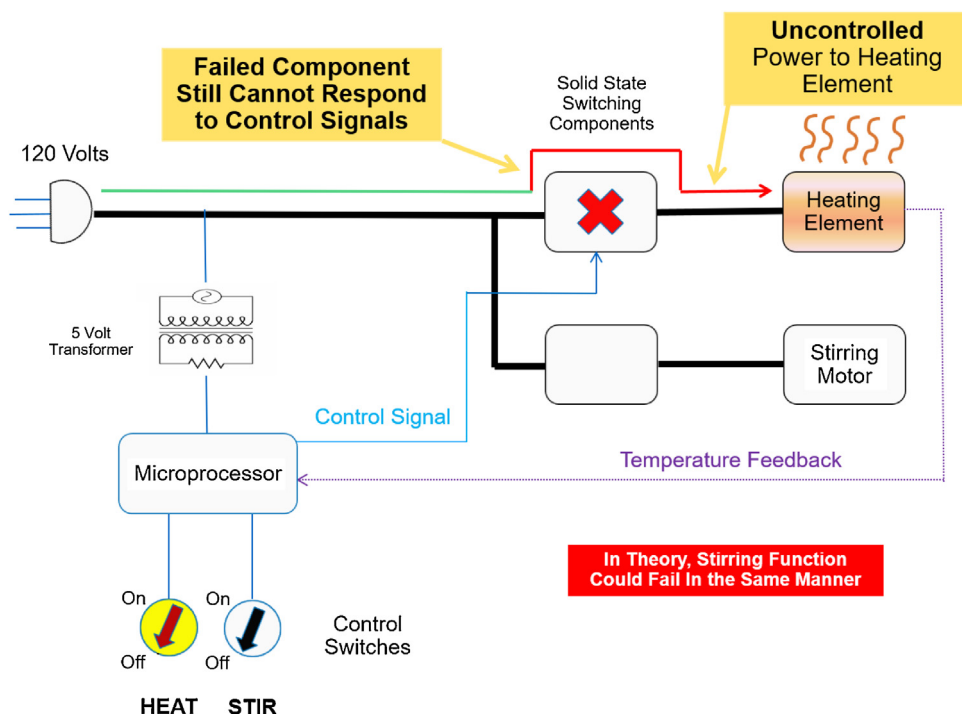
The heating control switch has been turned off. But, the failed solid state switching component still passes 120-V power to the heating element, permitting the hot plate to stay hot because the microprocessor cannot control the switching component (Figure 6).

Figure 6. Electrical schematic for hot plate showing effect (spontaneous uncontrolled heating) of failed solid state switching component when heating controls are in off position.
